# Intel<sup>®</sup> Pentium<sup>®</sup> III Processor Specification Update

Release Date: March 2002

Order Number: 244453-039

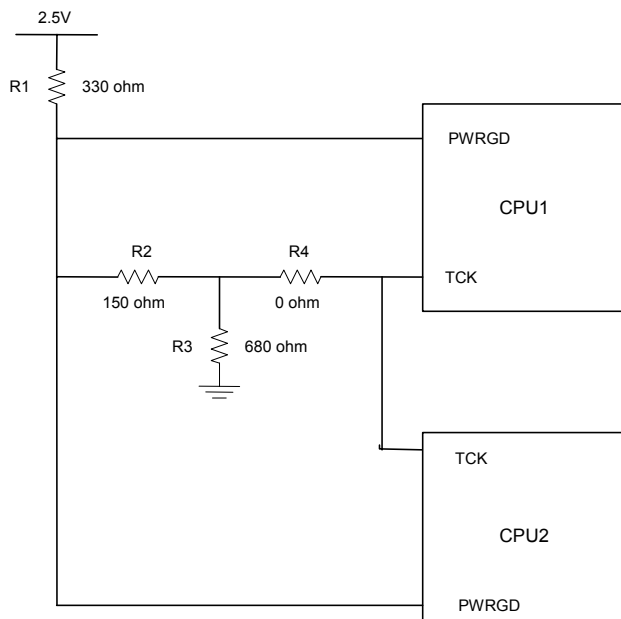
Pentium® III Processor with 512KB L2 Cache Platforms Workaround

In addition, the example workaround circuits shown do not support production baseboard test methodologies that require the use of the processor JTAG/TAP port. Alternative workaround solutions must be found if such test capability is required.

- The example workaround circuit assumes that the PWRGD inputs into the processors are open collector. Tying the PWRGD inputs together in a Wired-AND fashion allows each processor to receive PWRGD at the same time but at the latter of the 2 separate PWRGD assertions. If separation of the PWRGD inputs to each processor is required, extra circuitry will be required.

Assumes the inputs to the CPU\_PWRGD are open collector signals that are Wire-ANDed together

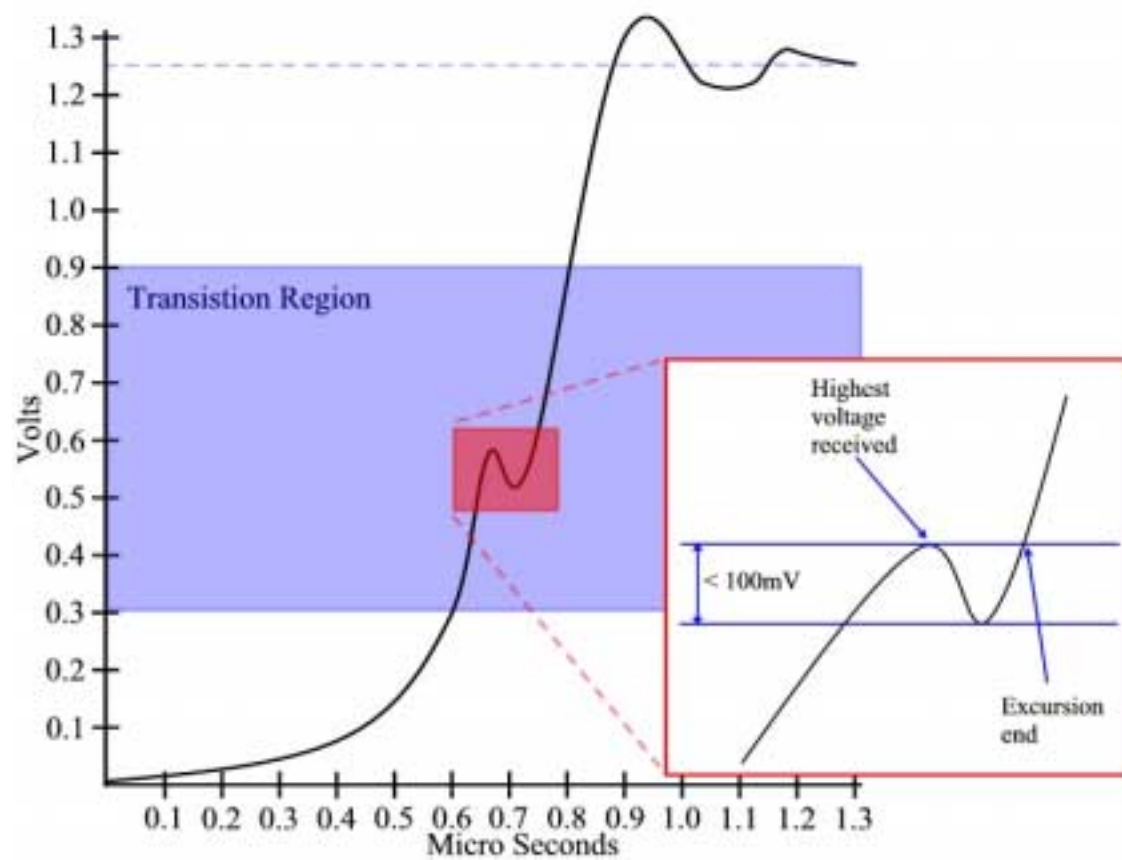
**Figure 1: Noise Estimation**

The signal quality of the VTT\_PWRGD signal is critical to the correct operation of the processor. Every effort should be made to ensure this signal is monotonic in the transition region. If noise or glitches are present on this signal, it must be kept to less than 100mV of a voltage drop from the highest voltage level received to that point. This glitch must remain less than 100mV until the excursion ends by the voltage returning to the highest voltage previously received. Please see Figure 1 for an example graph of this situation and requirements.

This change will be incorporated into the next revision of the Datasheet.
